SINGLE-CYLINDER ENGINE TESTS OF POROUS CHROME-PLATED
CYLINDER BARRELS WITH SPECIAL BORE COATINGS
FOR RADIAL AIR-COOLED ENGINES

By Robert L. Johnson and Roy I. Anderson

Aircraft Engine Research Laboratory
Cleveland, Ohio

NACA ARR No. E5L18a

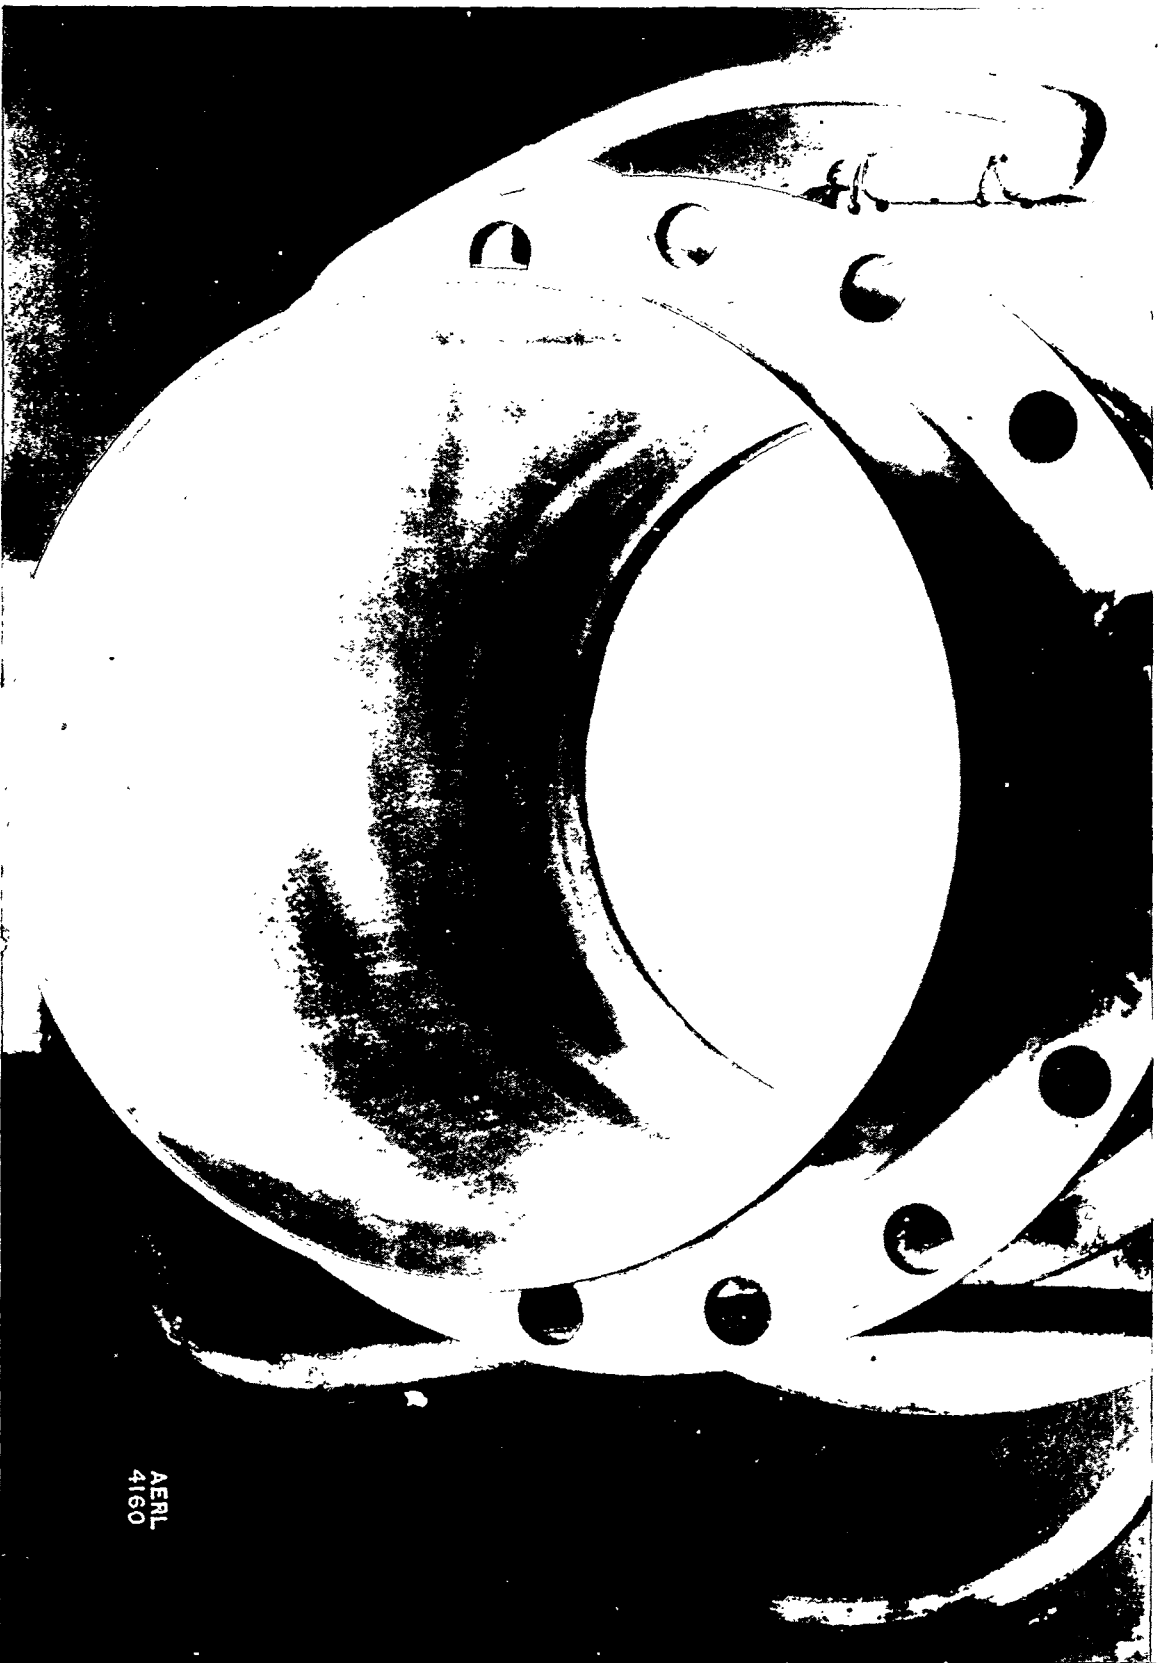
Figure 9. - Downstream face of choke-bore porous chrome-plated cylinder barrel with a silver overplate. Condition after test 8.

areas in which the silver did not completely adhere. The irregularity of the appearance of the bore shown in figure 9 does not indicate harmful operating characteristics. This observation is substantiated by figure 10, which shows the piston assembly run in test 8; the assembly is considered to be in very good condition.
